September 2016 Flood Report

Flooding in West Berkshire

Flood Investigation Report – September 2016

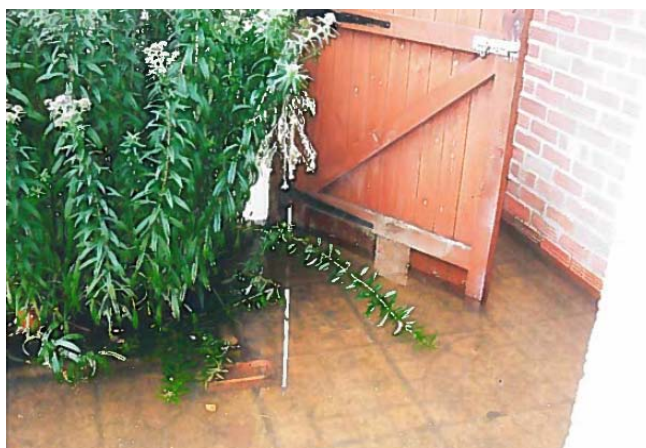
4. A large volume of water was also seen to flow overland across the footpath on the north side of Bartlemy Road. It then flowed off the footpath and down the driveway of No. 44 and 46. Water flowed into the garage of No. 44 and into the back garden causing flooding across the whole of the back garden of up to 200mm deep in places. The carpets in the front room of No.44 were flooded and the internal electrical wiring damaged. The water did not enter through the doorway but rose up from the suspended floorboards below.

Figure 1 – External flooding at 44 Bartlemy Road

9. Water flowed straight down the footway with no drainage or points to intercept the flow. A survey and investigation should be carried out to assess the potential benefit of creating an interception 'hump' across the footpath angled towards the carriageway. This would potentially divert water off the footpath and into the carriageway and prevent the water flowing down the driveways towards the properties. **(West Berkshire Council)**

10. The garage of No. 42 is a barrier to the flow of water, and causes the water to accumulate at the front of the property. The resident stated they are planning on drilling some holes to allow water to pass through the garage and into the garden.. **(Homeowner)**

11. Water overtopped the brick course surrounding the air bricks and filled the chamber around the bricks which are below ground level. Raising the threshold of the brick chamber by adding courses of bricks should significantly reduce the risk of the water overtopping and filling the airbrick chamber. Alternatively the existing airbricks could be replaced with self sealing airbricks. **(Homeowner)**

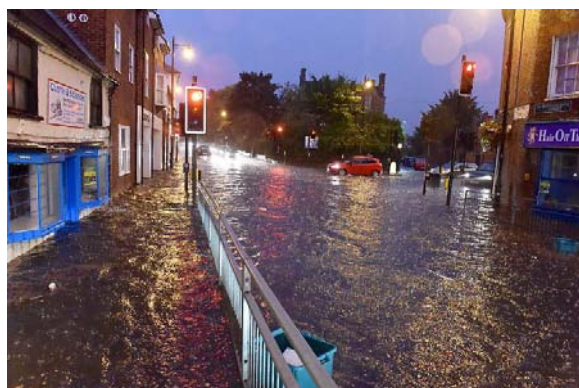
1. High intensity rainfall on the evening of 15th September caused the road junction to flood. The extent of the flood covered the entire carriageway and the footways and right up to the buildings on both sides of Bartholomew Street, east to west, from Station Road to the north to approximately the centre line of Pound Street to the south of the junction. Property number 79 had the deepest flooding which was over 500mm deep at the front of the shop. The water entered the shop at approximately 8pm on 15th September and remained there until 11pm. The shop floor is stepped down from the road and pavement outside. The shop front has old wooden doors with visible gaps around the edges. Water was seen to flow directly through the door onto the shop floor. Following further rain at approximately 4am on 16th September the water flooded the shop front again but had drained away by 8am. The shop owner stated that this is the third time they have flooded in three years but this was the deepest it had ever flooded.

3. Eye witnesses stated that the highway drainage was seen to be flowing however it was overwhelmed by the large volume of water causing the junction to flood for over 4 hours. The junction had drained clear by 9am the following morning..

Figure 2 – Flooding in Bartholomew Street. credit Newbury Today

4. The highway drainage system was seen to be flowing however, following the flooding the drainage system was visually inspected and silt was found in parts of the systems. Maintenance cleansing of the drain pipes and gullies should be carried out as the flood waters will increase the likelihood of silt and debris entering the system which could cause further blockages. **(West Berkshire Council)**
5. The shop owners are advised to invest in property level protection (PLP) to prevent water entering the buildings. Flood doors or flood barriers for the doorways would be recommended as this was the point of entry for most of the floodwater. For property number 79 water may also have entered through the brickwork; a specialist flood contractor should be contacted by the owner to provide advice on options to waterproof the external walls of the property. **(Property owner)**

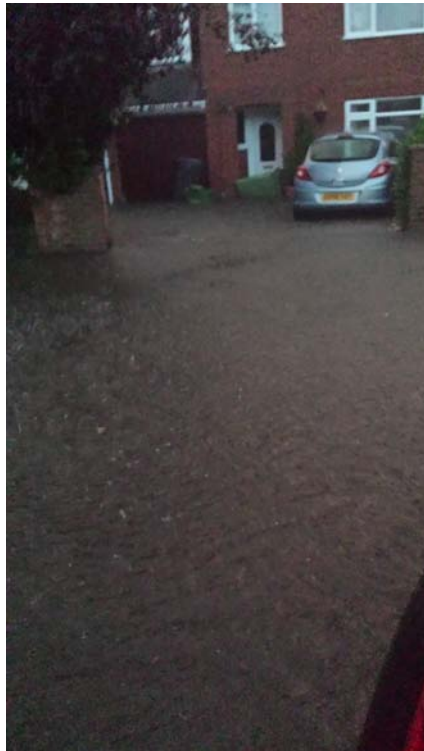
1. The severe storm on 15th September 2016 resulted in surface water flooding in Paddock Road. Water flowed across Paddock Road from east southerly direction and collected at the low point outside properties No. 14 and 16, causing the carriageway to flood at this location. There is highway drainage in Paddock Road in this area which normally copes with normal heavy storms.. However, there is a recurring problem of highway flooding here during medium intensity rainfall. The rainfall on the evening of 15th September was exceptionally severe and it overwhelmed the drainage system causing water to flow across the driveway and into No.16.

Figure 3 – External flooding at 16 Paddock Road

2. A CCTV investigation of the existing highway drainage system was carried out in 2015. The survey found the section of the system that could be accessed was clear and flowing. However, the whole of the network could not be accessed so the full condition could not be established. After the flooding on 15th September 2016, further jetting of the entire system in Paddock Road was undertaken. The drainage system along Paddock Road was found to be separate to the gullies outside No. 16. This separate system has now been jetted out. The survey established the exact point where the network appears to stop. This point was located and a trial hole was dug to establish the current condition of the pipe. This investigation found that the outgoing pipe has been severed and buried beneath the Willow Close development land.

3. The severed pipe should be repaired and extended to an outfall point to allow the water to drain from Paddock Road. A surface water manhole, approximately 10 metres from the damaged pipe, was identified to connect to within the adopted highway. This repair work was completed in February 2017. **(West Berkshire Council)**

4. In addition to the repair of the damaged drainage pipe the property owner may wish to install property level flood protection measures such as flood boards or flood doors. **(Property Owner)**

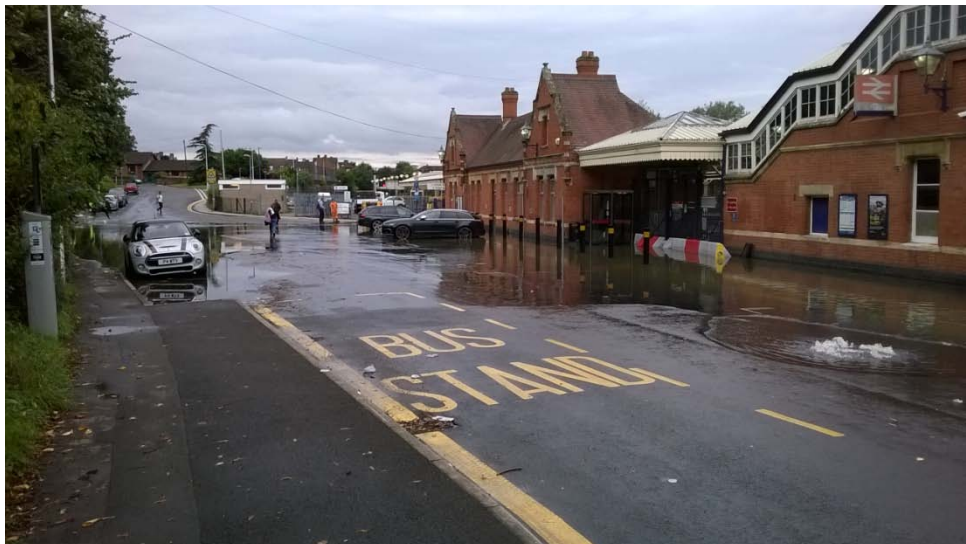
2. Approximately two hours after the initial surface water flooding the water began to escape from the foul sewer network due to surface water infiltration higher up the foul sewer network. Flood waters were seen to flow out of four foul water manholes along Station Road. This caused further flooding in the same low point of Station Road and caused contaminated water to flow across the platform and onto the flooded train tracks.

3. There has been flooding in this location previously and investigations found that the outgoing pipe from the lowest gully along Station Road outside the westbound ticket barrier had been severed during works by Network Rail when making improvements to Newbury Rail Station. This has resulted in frequent flooding from the highway gully at the low point of Station Road as there is no outlet for the water. A pump has been installed by Network Rail in the chamber of this gully to pump the water via flexible hose laid in the station car park into the track drainage at the west end of the platform. This has been successful in reducing the flooding during smaller, less intense, rainfall events. The pump was working during the flooding on 15th September but the volume of flood water exceeded the capacity of the pump so it was not able to stop the flooding along Station Road. The flooding was exacerbated by the large volume of surface water entering the foul sewer network which flooded out onto station road two hours after the initial flood event.

Figure 4 – Flooding of Station Road and foul manhole flooding

4. West Berkshire Council should ensure the highway gully system is working and carry out maintenance/jetting of any gullies that are not clear. **(West Berkshire Council)**

6. A large volume of surface water is entering the foul sewerage network leading to contaminated water surcharging and flooding the Station Road area. Thames Water Utilities should investigate the upstream network to establish points of surface water infiltration so these can be repaired. **(Thames Water)**

7. Thames Water Utilities should investigate the upstream surface water network to establish if there are points in the network where the surface water that is flooding Station Road can be diverted into an alternative network. **(Thames Water)**

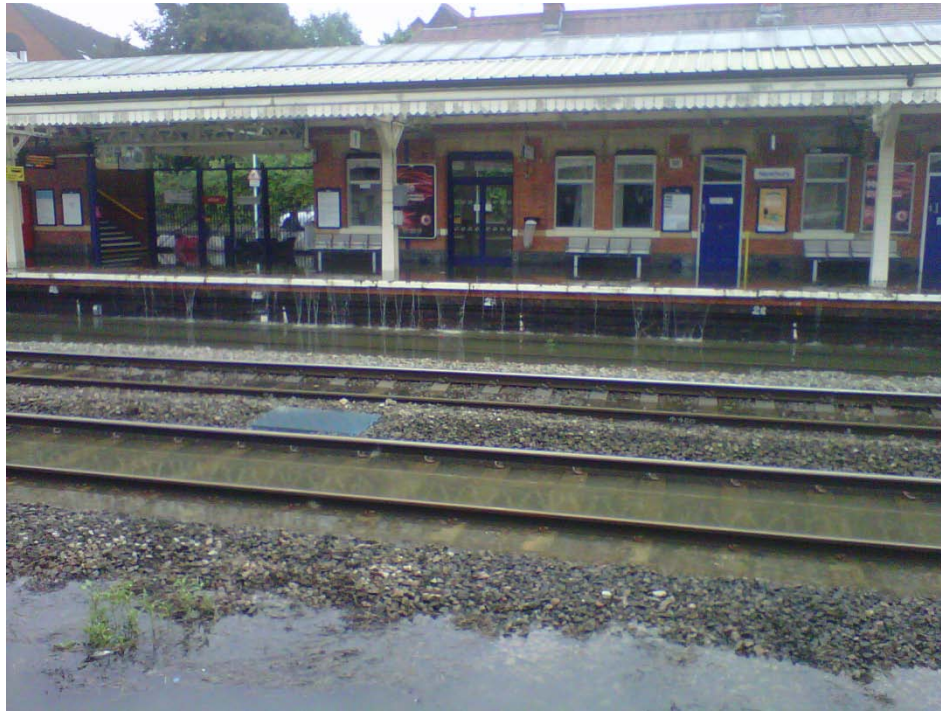
1. High intensity rainfall on the evening of 15th September 2016 led to surface water runoff which collected on Station Road to the south of Newbury Train station. As the flood depth increased the flood water overtopped the kerb stones and flowed over the footway through the train station barriers, then across the platform and into the train tracks. This caused the train track area to become flooded.

Figure 5 – Train Station and track flooding. Water flowing over the platform

5. Network Rail should investigate the possibility of increasing the capacity of the pump to clear away surface water flood water quicker. A preliminary proposal for a permanent solution has been drawn up using large diameter storage pipes under the station car park but this is not programmed for implementation until 2019. **(Network Rail)**
