Colthrop Village, Thatcham

Preliminary Ground Condition Assessment

Project Ref: 30738/3501 | Rev: Rev2| Date: December 2016

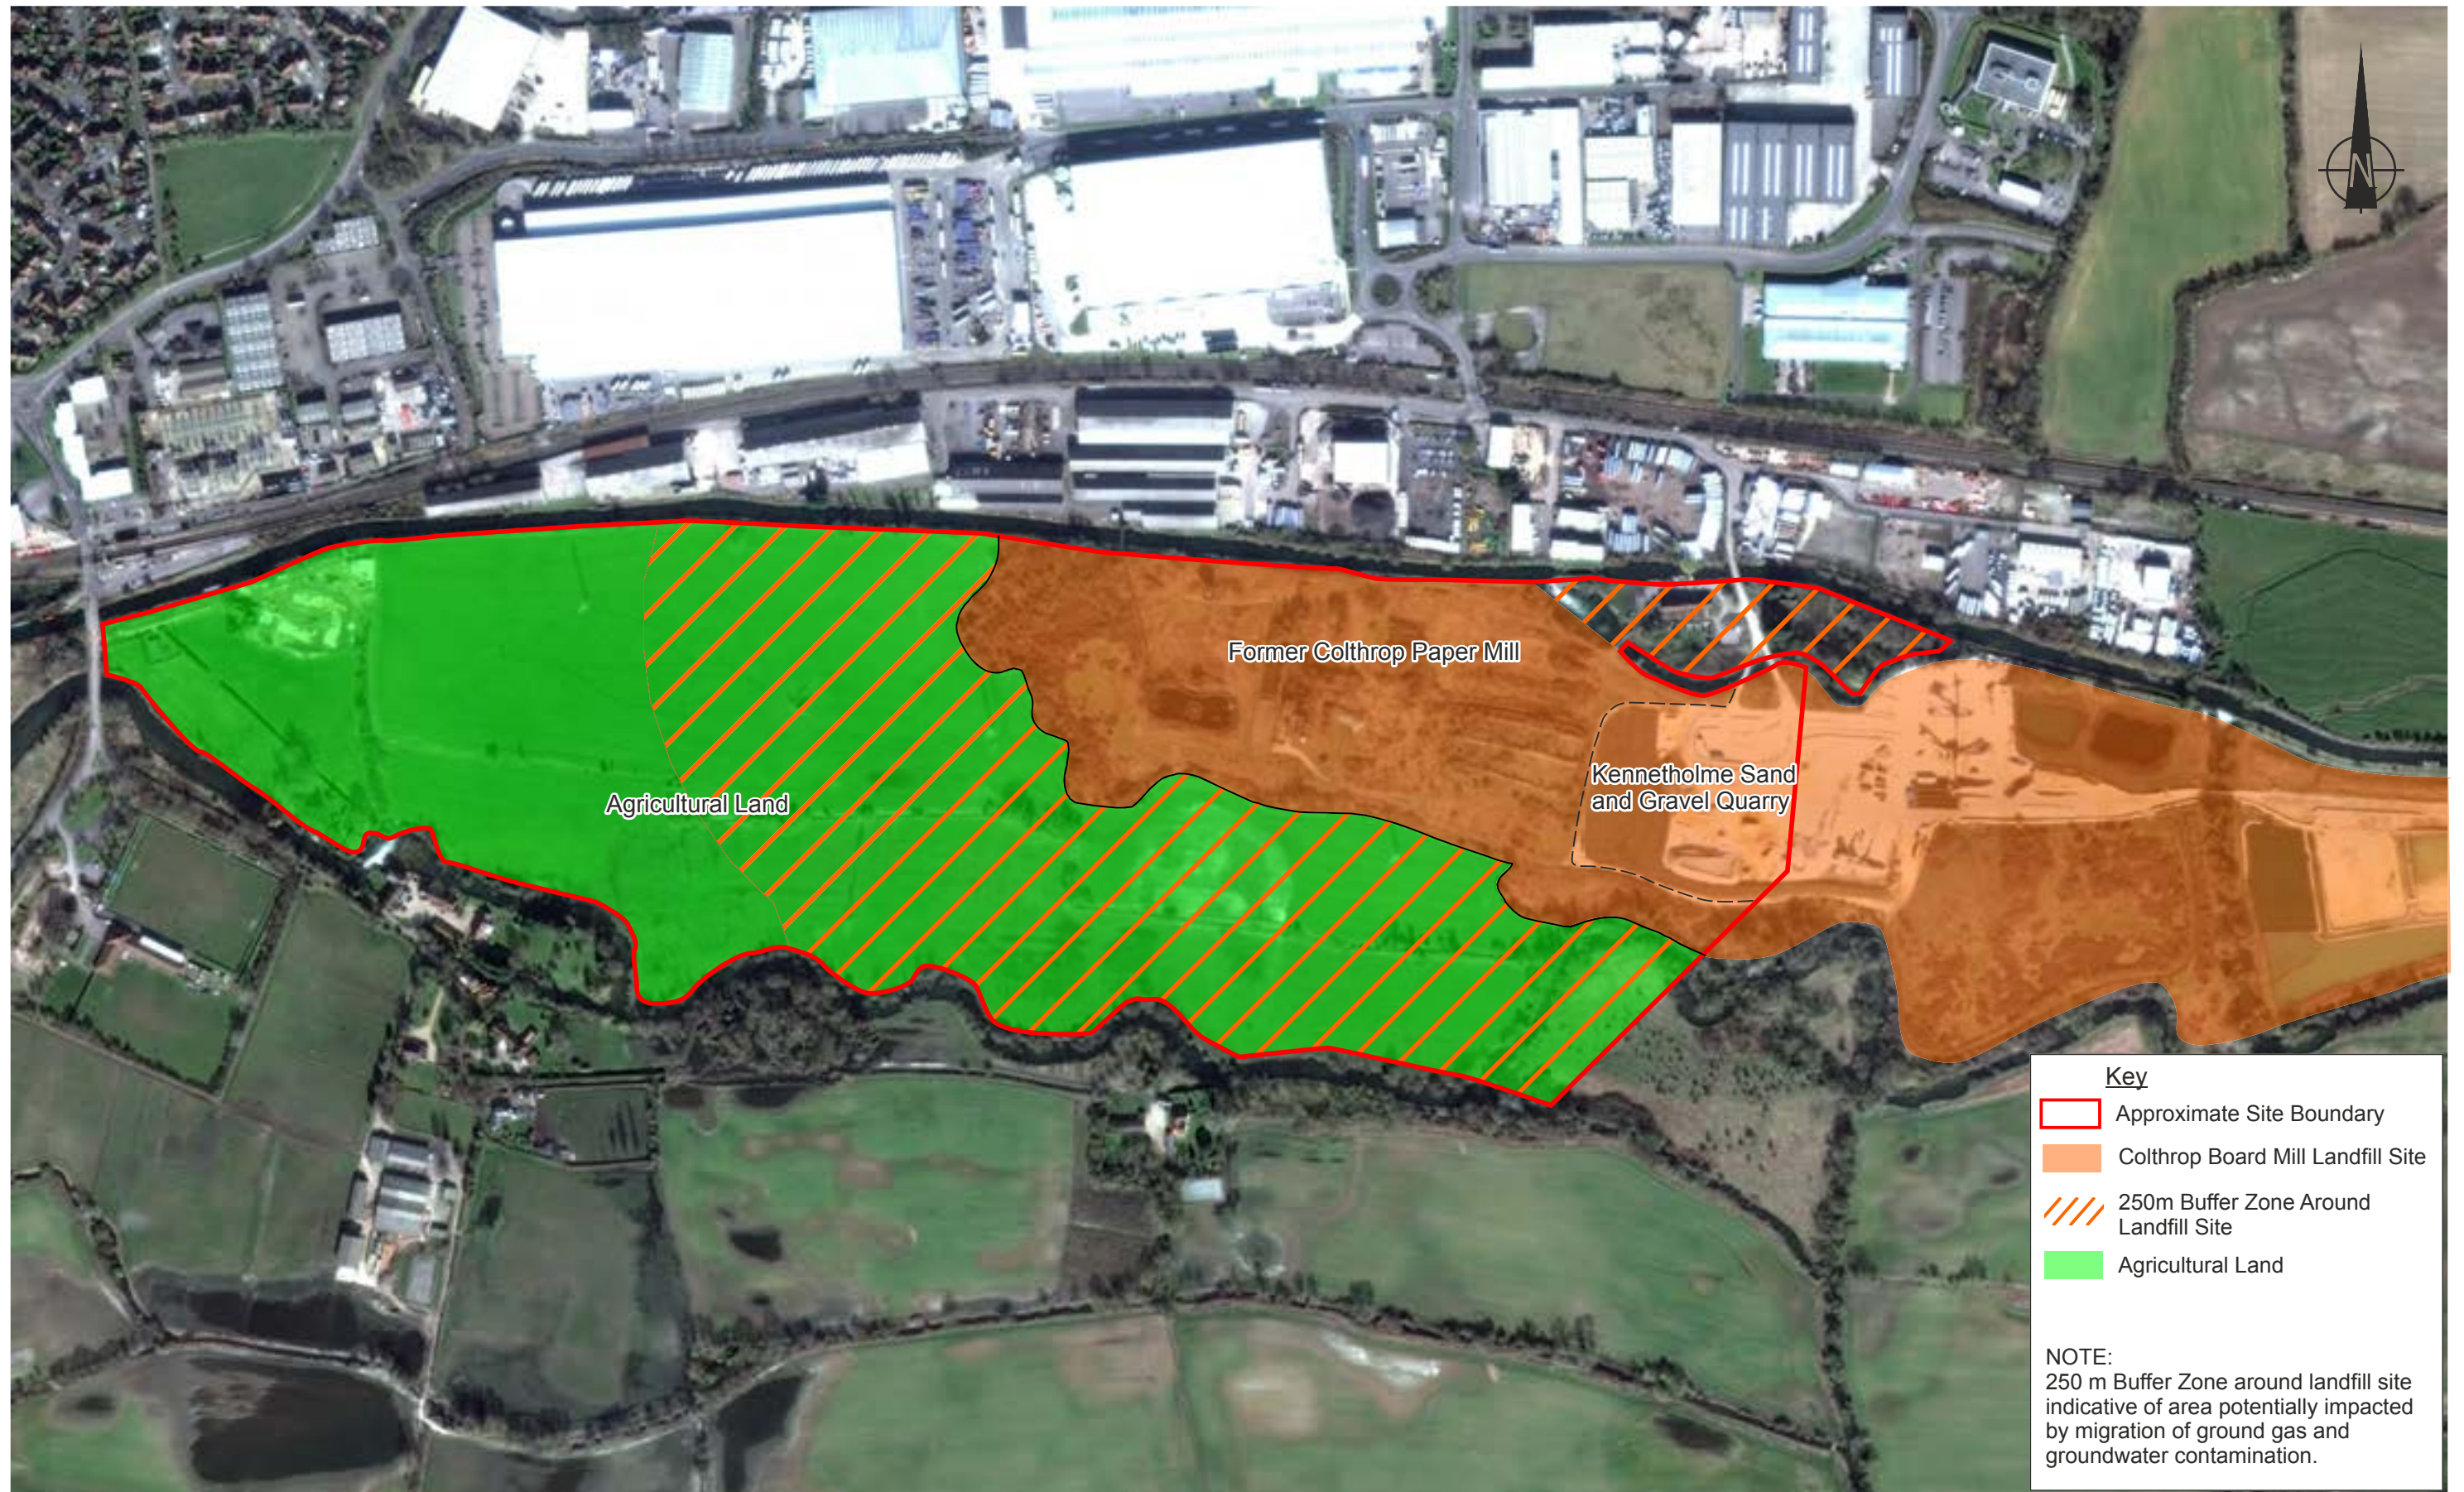
| Clay | | |

SU56NW79

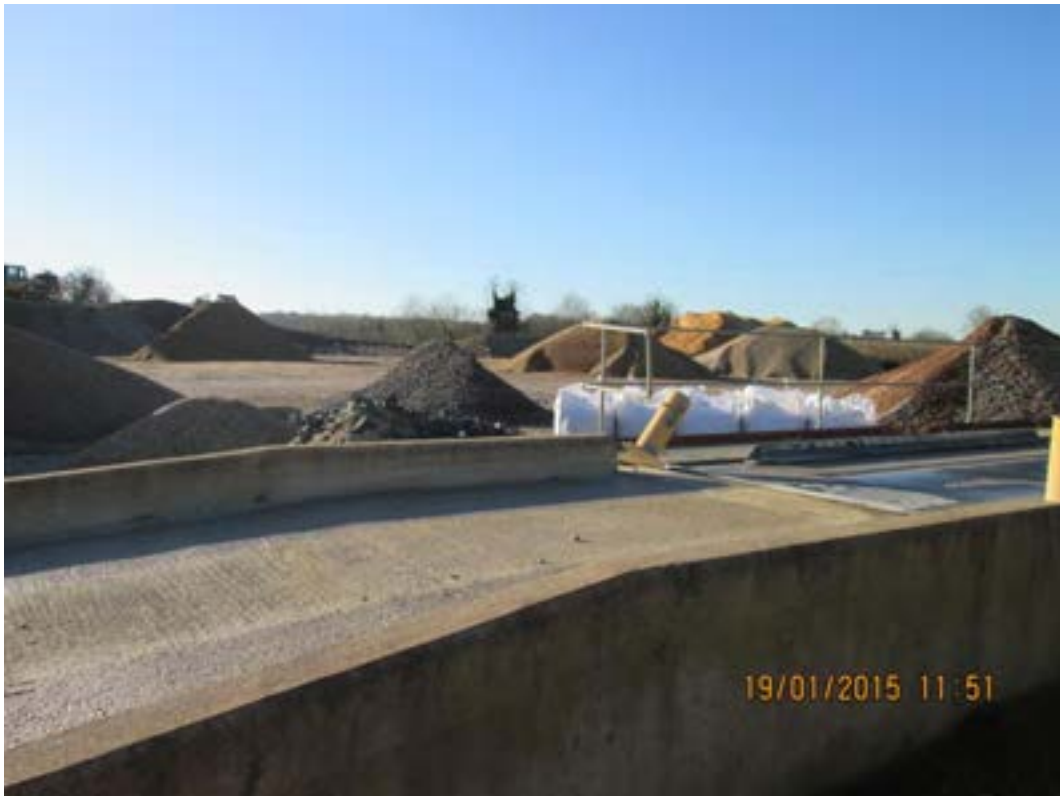
Plate 2: Stock Piles of Sand and Gravel in the east of the site

At the time of the walkover Kennetholme Quarry was an active Sand & Gravel Quarry operated by Grundon Sand & Gravel Ltd. The western part of the quarry (which is situated within the subject site boundary) comprises offices and a car parking area, and stockpiles of sands and gravel (Plate 2). The remainder of the quarry is located to the east of the subject site boundary and comprises sand and gravel processing plant (Plate 3).

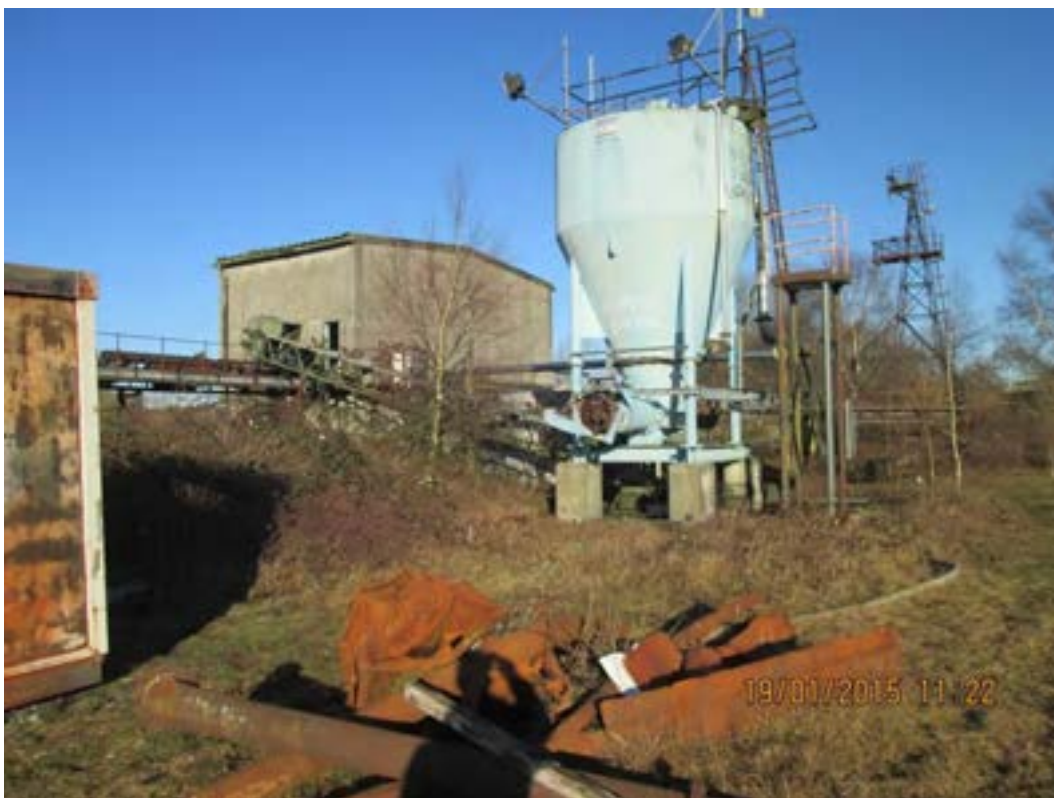
Plate 6: Overview of relict machinery

The large redundant building, covered with corrugated cement sheeting is present at the centre of the site (Plate 6 & 7). The building was not accessed at the time of the visit. A former fuel oil tank is present adjacent to this vacant building (Plate 8). No evidence of leaks or spillages were noted.

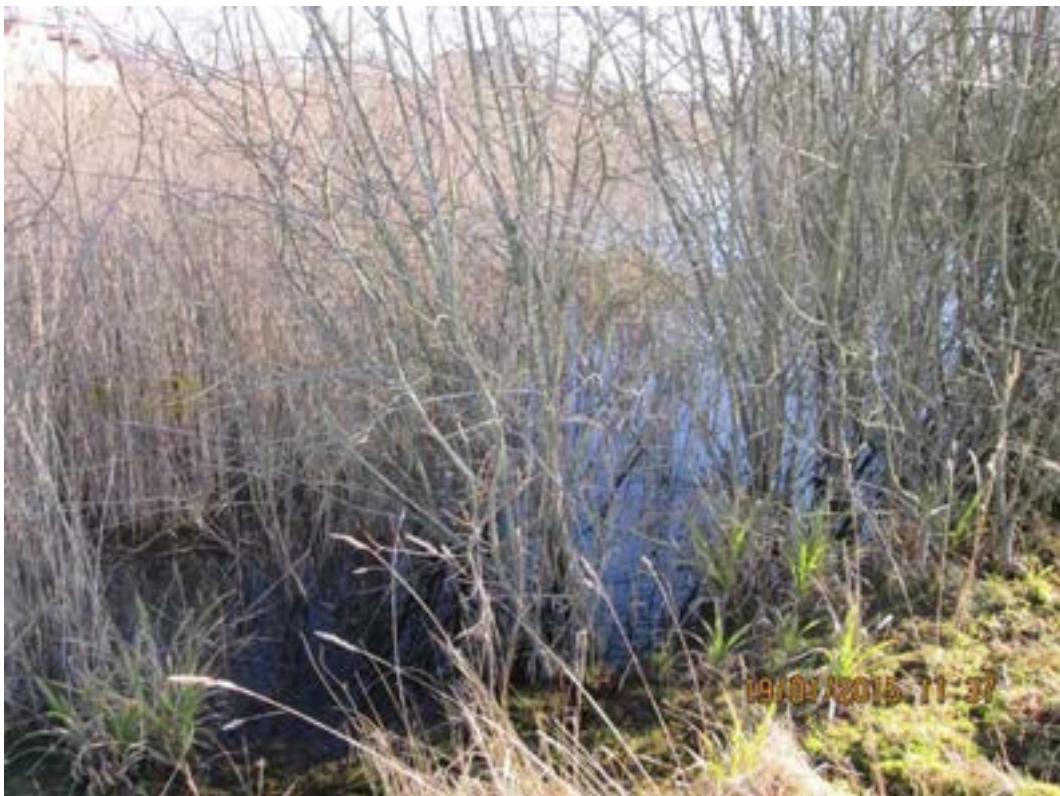
Plate 9: Deep water feature in the south west of the landfill

A pond/lagoon is present within the south west part of the former paper mill (Plate 9). The outline of further former settlement ponds, which have been subsequently infilled were observed during the walkover. See Figure 2 for approximate location.

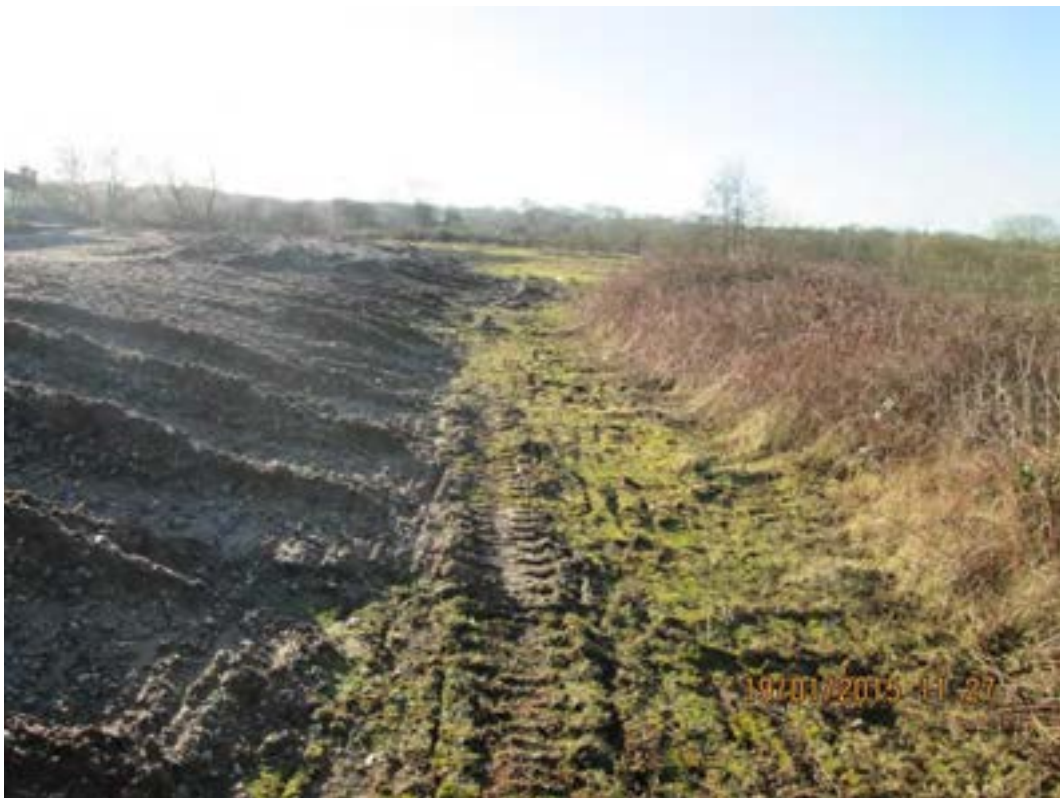
Plate 10: Infilled filter beds adjacent to the west of the control room

The land at the former Colthrop Paper Mill is noted to be raised by about 1 to 2 m above the surrounding agricultural land ground to the south and west. (Plate 14). The former filter beds present within the site (see Figure 2 for location) appeared to be backfilled with an unknown material (Plate 10).

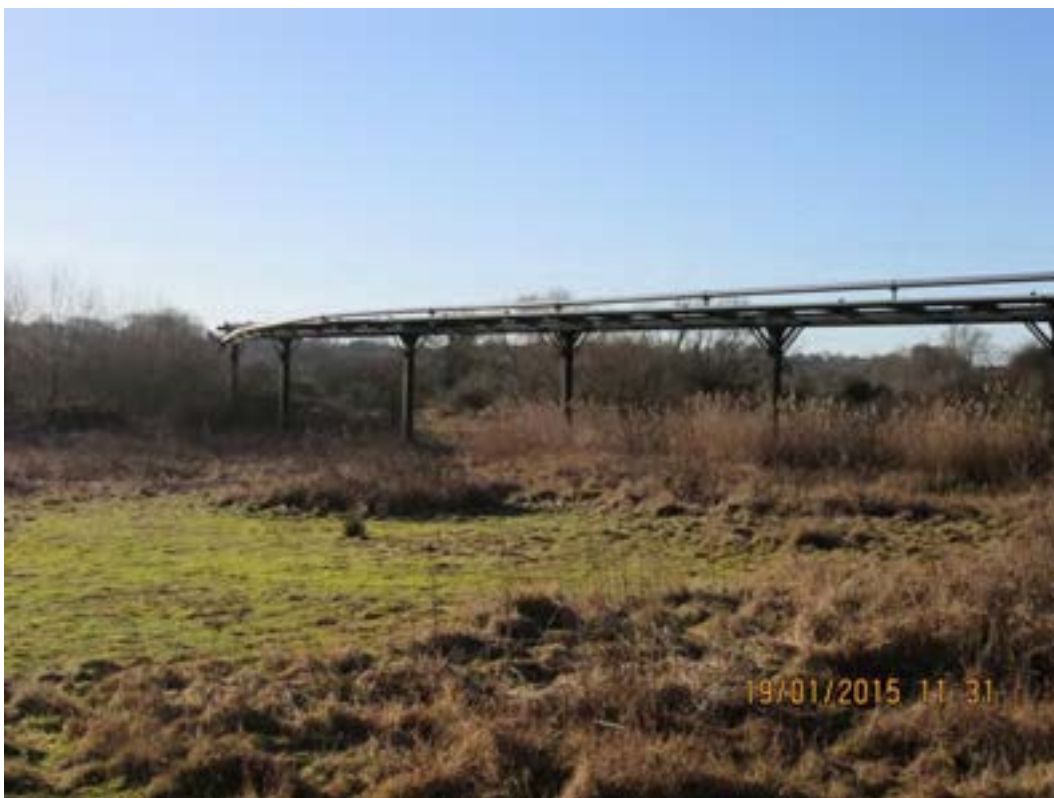
Plate 12: Overhead pipe / conveyor belt leading to an off-site location

An overhead pipeline crosses the Kennet and Avon Canal from the site to the north (Plate 12).

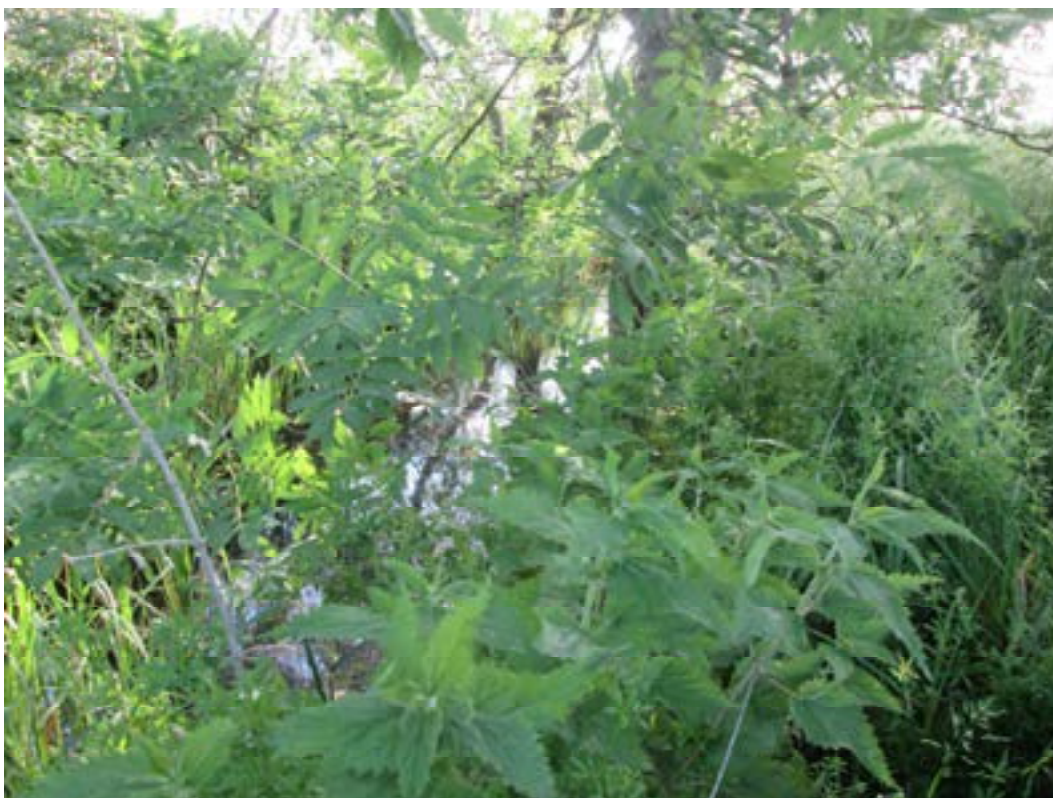
Plate 20: Ditch/stream filled with water

The agricultural fields can be split into two large fields, north and south, separated by hedgerow in the western most part of the site and a drainage ditch in the centre and the east. The ditch was observed to be filled with water (Plate 20) in the east while the ditch in the centre of the site was dry at the time of the site walkover. Livestock occupies the northern field which appears to be well maintained (Plate 16). The remainder of the agricultural land comprises open fields that are overgrown with grass (Plate 18, 19 & 21).

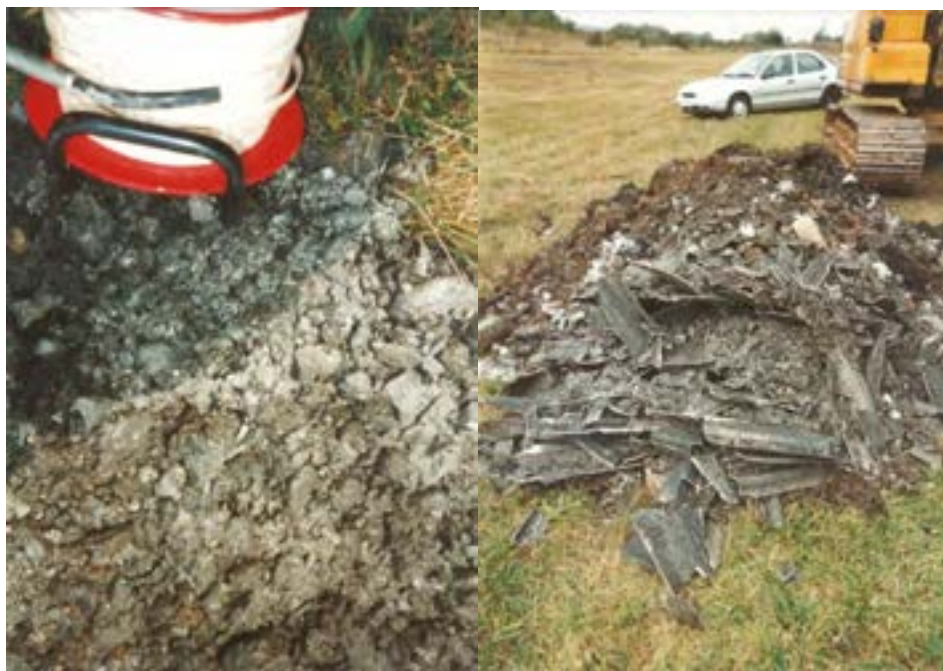
Plate 1. TP2 General Rubble Inert Fill 2.8m

Plate 2. TP2 Asbestos Roofing Tiles 1.2m

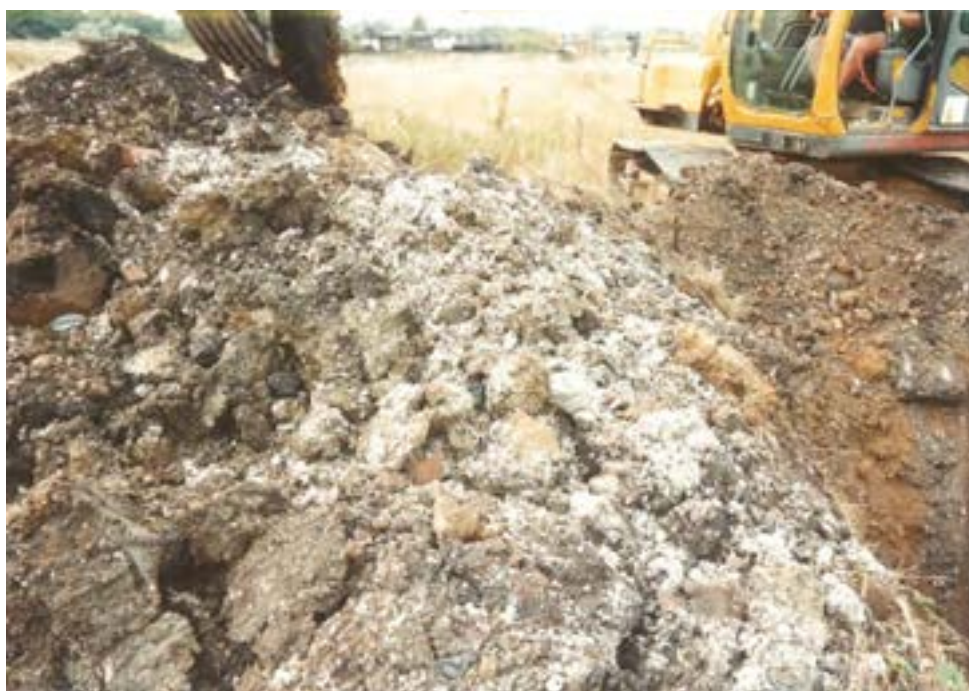
Within this matrix other waste was found and included, house bricks, wood, paper pulp, Thermolite blocks, rubber hoses, cables, black plastic sheets, asbestos roofing tiles, steel wire, (plate 5) and reinforced concrete.

Paper pulp was confined mainly to Zone A and was present in discrete layers except in TP 4, (plate 3) where larger amounts of paper pulp was found. Thermolite blocks were exclusive to Zone A with TP 6 showing large numbers of blocks, (plate 6). Asbestos roofing tiles were confirmed to TP 2 only, (plate 2). Zone B showed a more uniform made ground made up of general fill with some large blocks, reinforced concrete and metal wire, (plates 7 and 8).

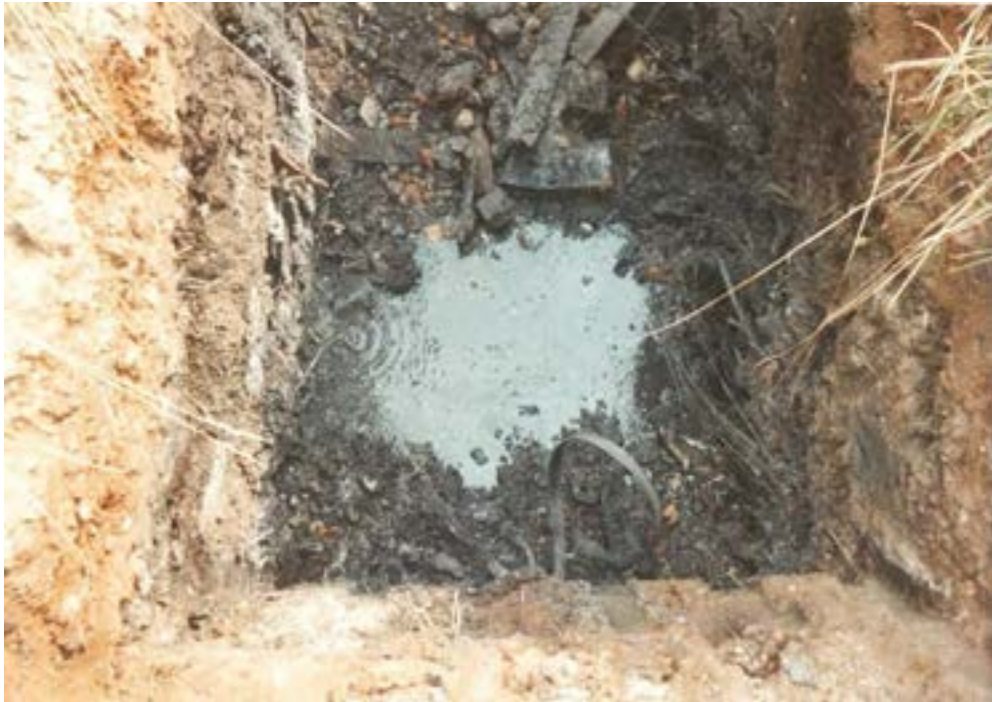
Plate 3 Paper Pulp mixed with Inert Fill 2.4m

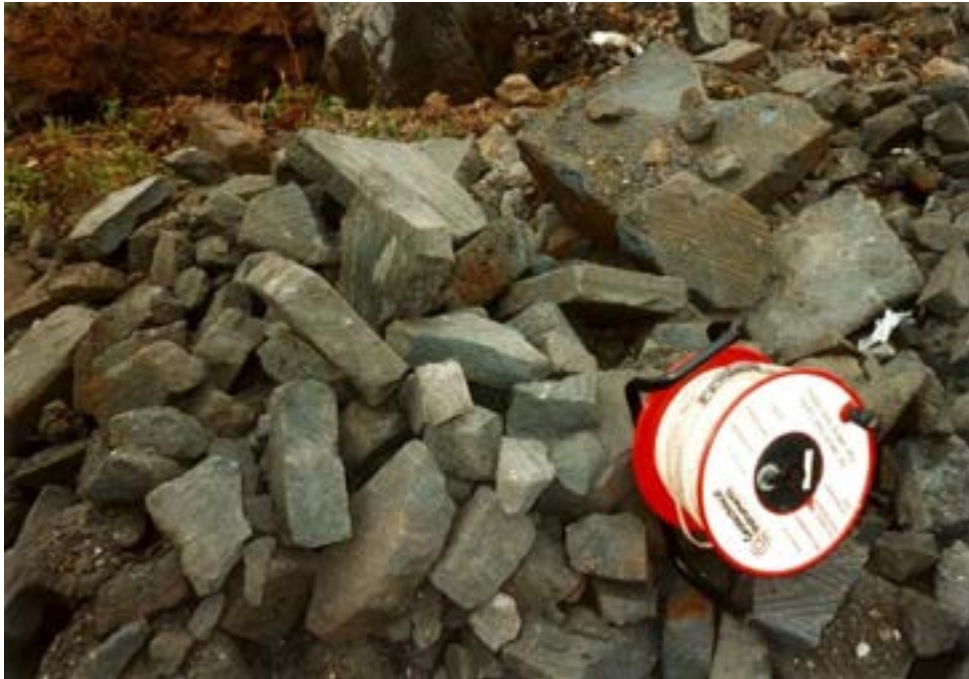
Plate 5. Wire mixed with Paper Pulp

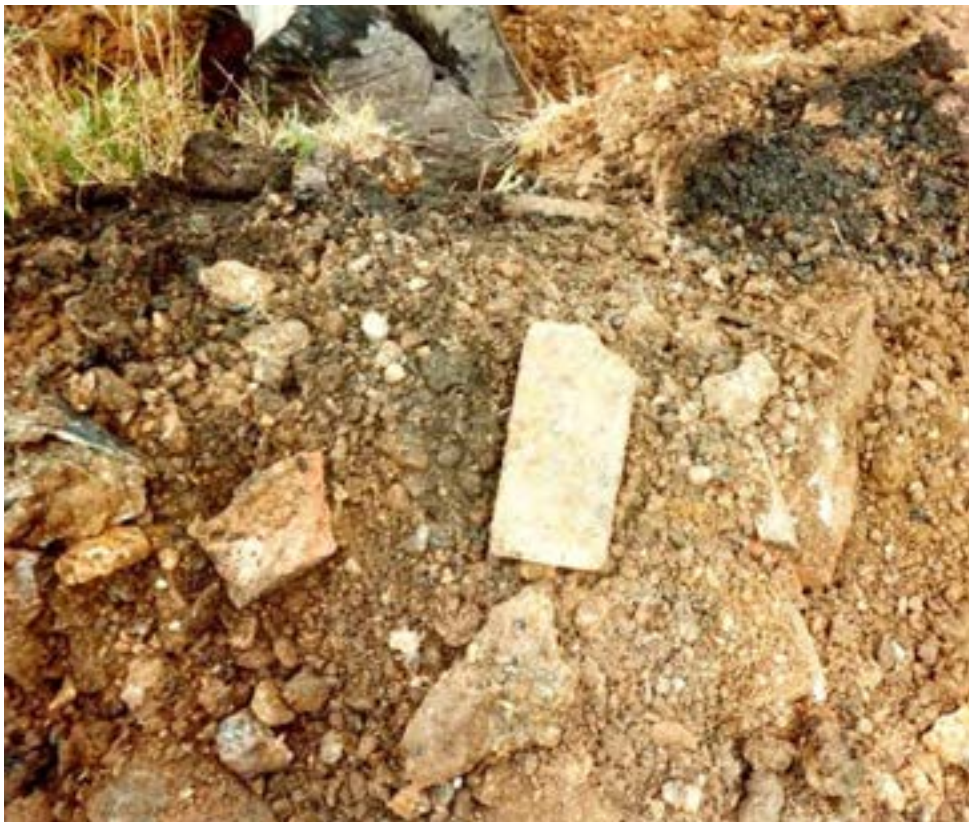
Plate 6. Thermolite Blocks 0.2 to 1.1m

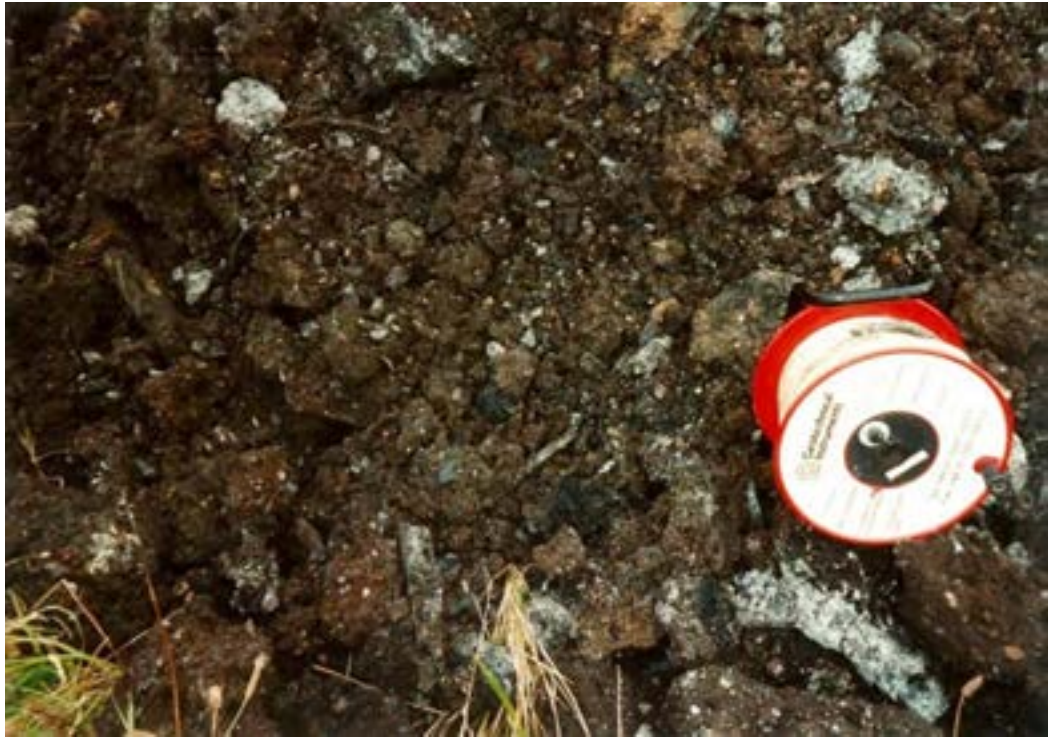
Plate 7. General Inert Fill, bricks and large blocks 0.5m

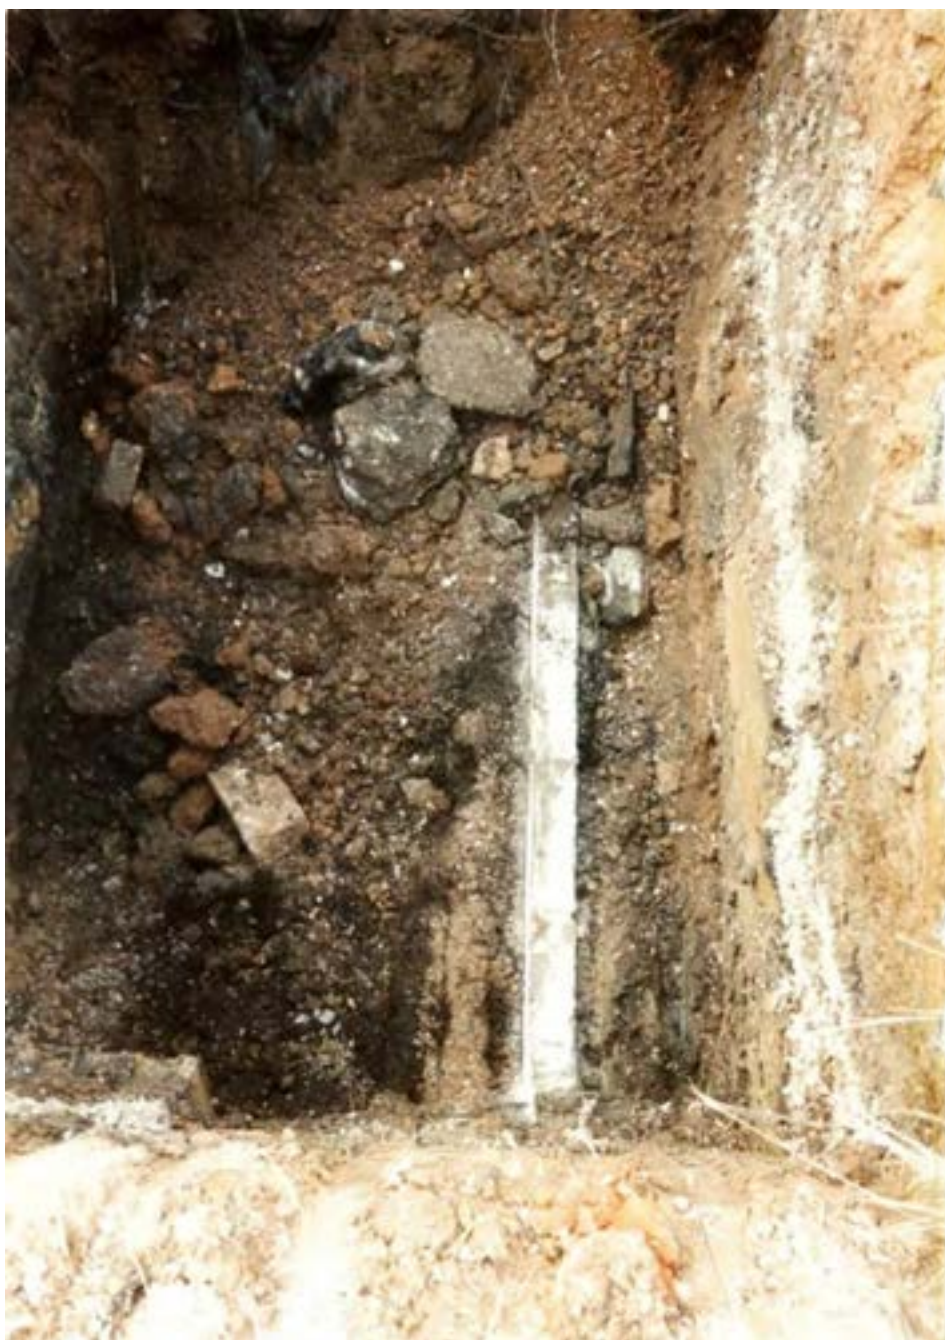
All pits encountered made ground to depths of between 2.9m and 4.5m. Zone B has a greater depth of made ground averaging 4.1m, with Zone A averaging 3.5m. All holes found a black, sometimes odorous “inert” type waste, (plate 1) mixed with rubble of various dimensions, (plates 1 and 8). TP1 and TP 2 also displayed black sludge, silty black mud or black clays with a hydrocarbon odour. Some light grey powdery ash material was present in TP1 at 0.7m below the surface.

Plate 8. Odorous Inert Fill 2.2m

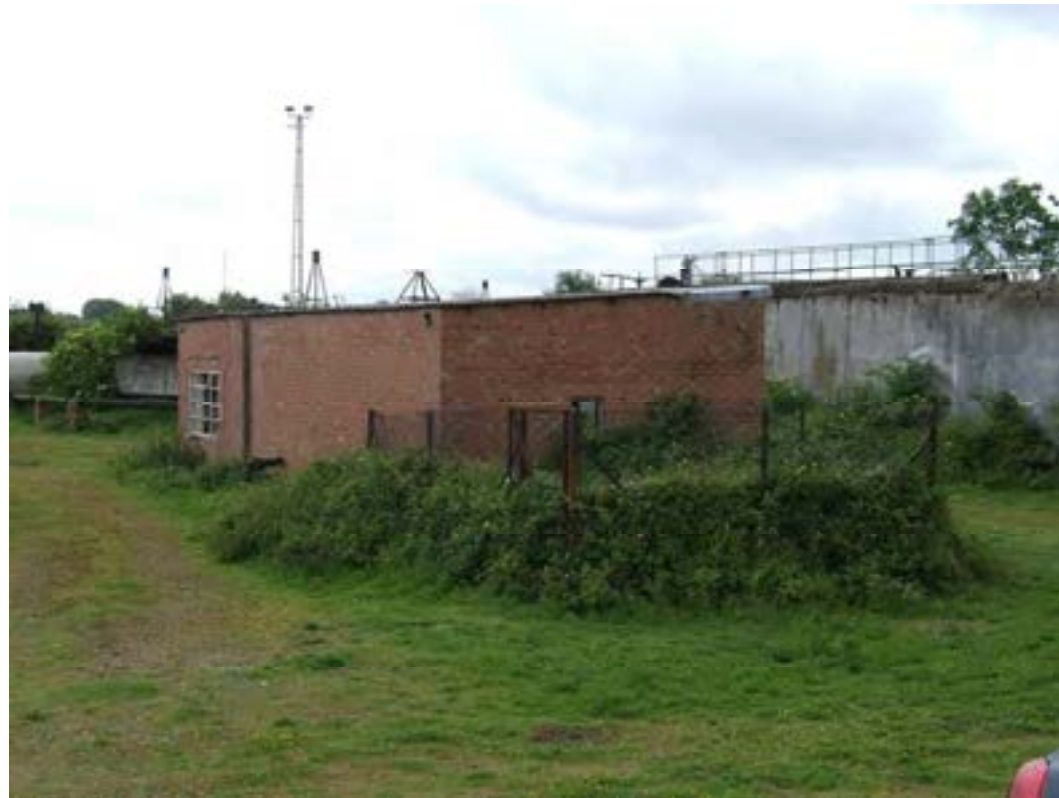
Figure 1 Existing Building – Location of Site Office

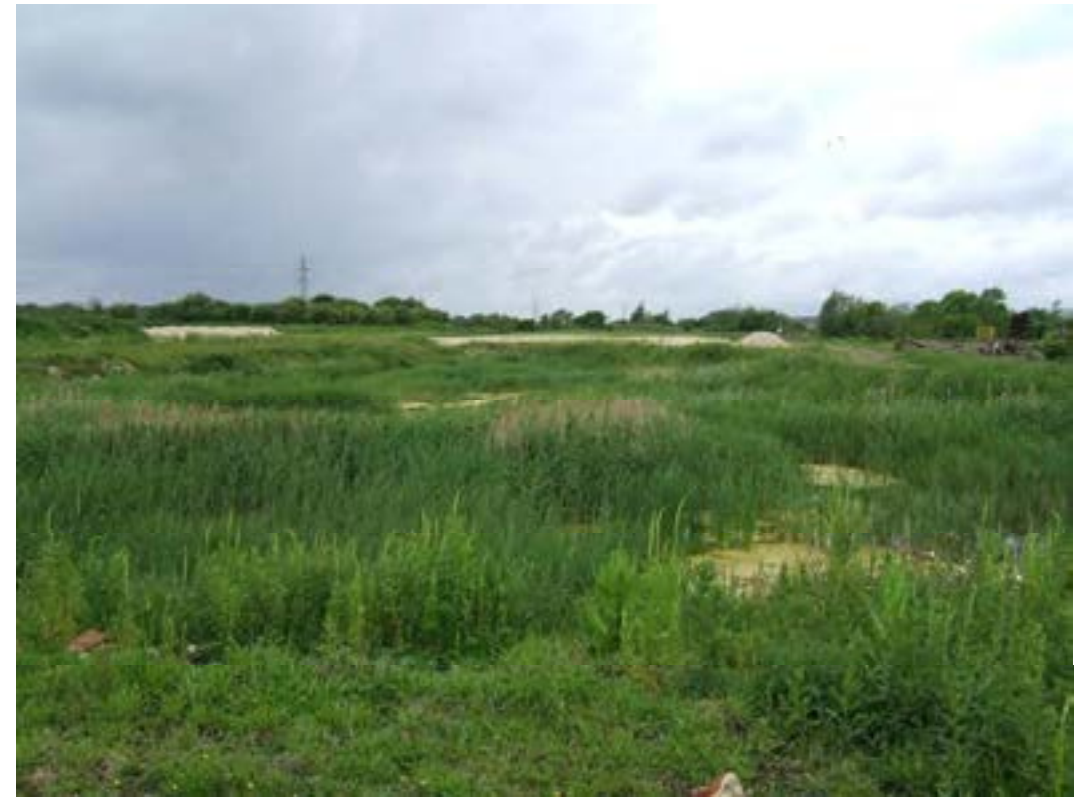
Figure 2 Existing Pond – Proposed Weighbridge Office/Mess Room
